SUBJECT Basement Shelter in Vilnius;
(description thereof;
plan of shelter; sketches of
filter system and entrance
door)

ATOMIC SHELTER IN VILNYUS

Atomic Shelter in Vilnyus

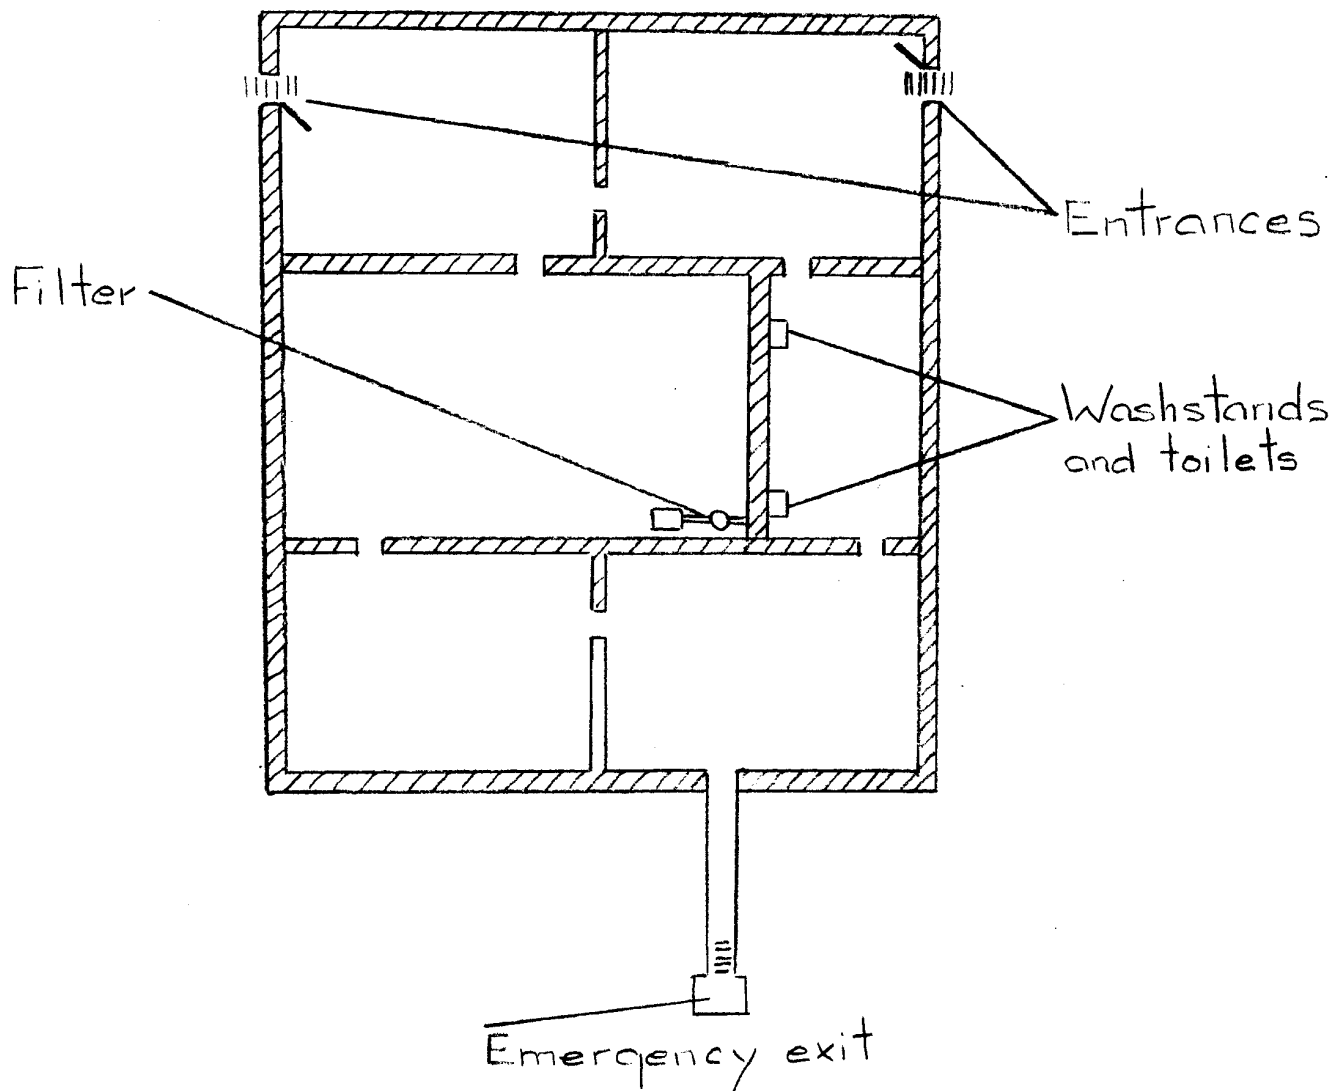
Atomic Shelter in Vilnius (No. 1)

1. In general all new houses had shelters more or less like the one sketched in attachment No. 1.
2. The following is [] description of an atomic shelter in the basement of the building [] in Vilnyus. 50X1-HUM

Shelter: It occupied all of the basement. The ceiling and walls were of concrete. [] 50X1-HUM

Interior: It was divided into several rooms without passages. The dividing concrete partitions were about 25 centimeters thick. Some of the rooms communicated with others by means of doors. [] the two doors of a room did not face each other. Each room was for several families. There was a room with toilets and wash-stands. 50X1-HUM

Emergency exit: It was at one end of the shelter [] it consisted of a passage leading to the patio. 50X1-HUM

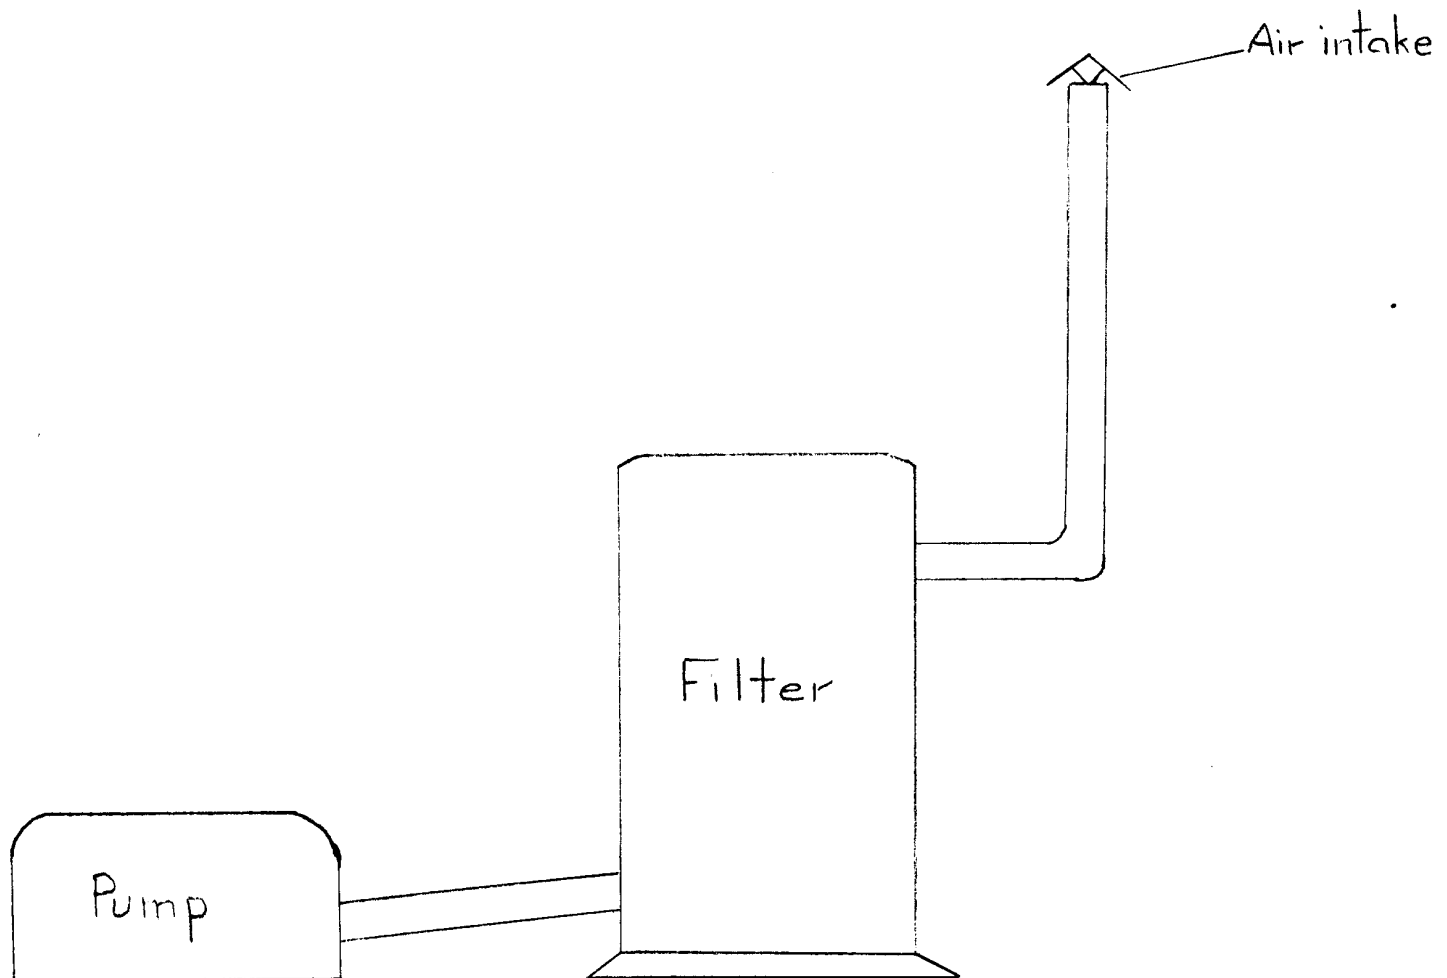
Filter for purifying radioactive air in an atomic
shelter in the city of Vilnyus (Alt. No 2)

Air filter: (See attachment No. 2.) There was an air filter in the central room. The kind of substances contained in the air filter were unknown [] Next to it, there was an apparatus resembling a motor [] believed [] a pump for drawing air through the filter. 50X1-HUM

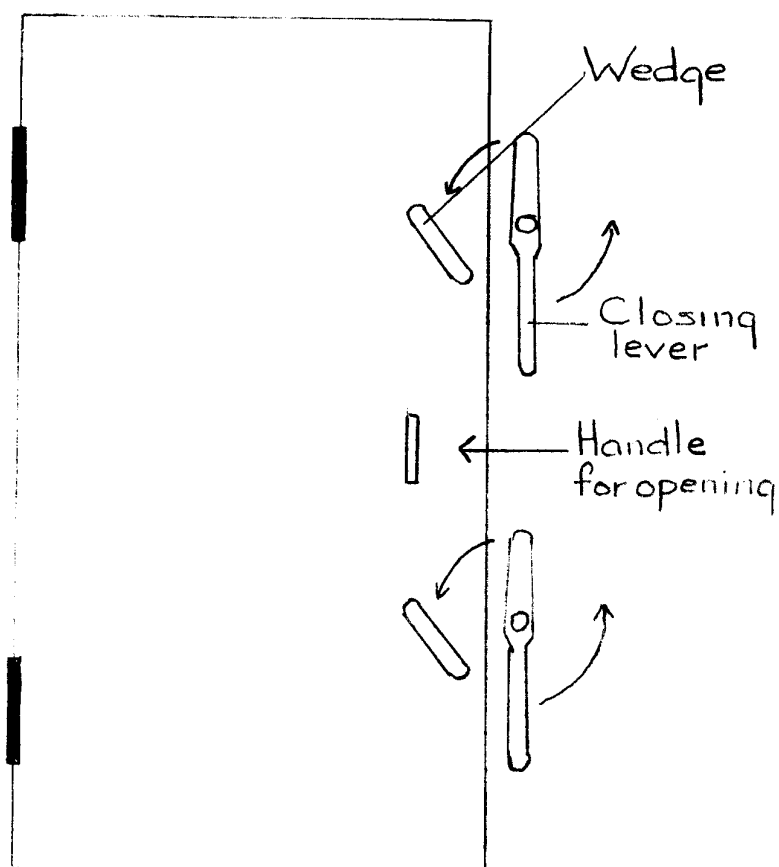
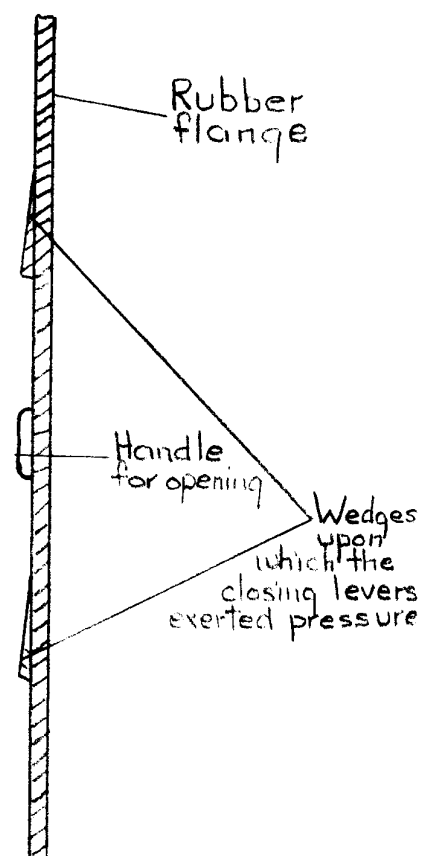
Entrance doors of an atomic shelter in the city
of Vilnyus (Att. No 3)

Doors: (See attachment No. 3.) The shelter had two entrances each with a stairway. The 2m x 0.85m doors were of ten millimeter thick steel with a smooth surface and a rubber flange around the edge which permitted airtight sealing. Two heavy hinges held the doors in place. Two closing levers attached to the wall lowered onto a kind of wedge welded to the door. The more the levers were lowered, the more tightly the door was closed.
